Background

History of the Natural Heritage Building (NHB) Pre 1997

The NHB was designed with many integrated pest management (IPM) related building features. Over the past fourteen years many of these features have continued to work as originally intended, with some requiring adjustments in order to gain their optimum functionality. Additional IPM features that were not originally considered at the time of construction have also been added.

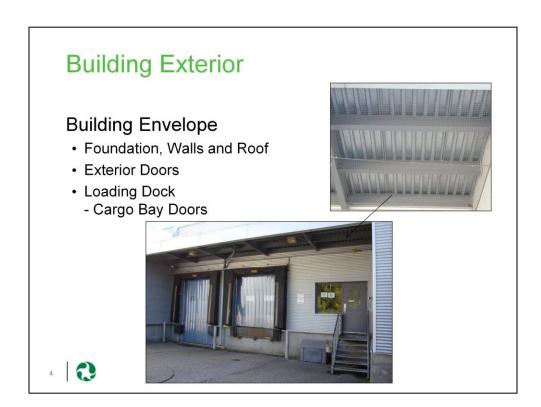
Loading dock cargo bay doors

A few years after moving into the NHB nesting and roosting activity by pigeons on top of the cargo bay door was discovered. Bird netting (wire screening) was installed above the doors, meant to discourage bird activity, and decrease the chance of other pests that are routinely found in nesting sites like dermestids and clothing moths. It was a successful addition, however, regular inspection and maintenance is necessary to ensure its continued functionality.

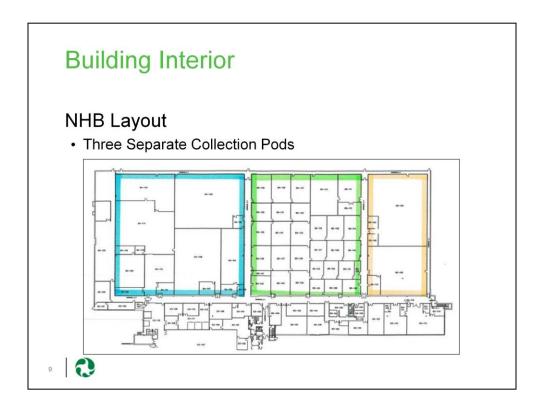
The NHB was designed to strategically separate certain areas of the building and incorporate particular features to assist with pest management.

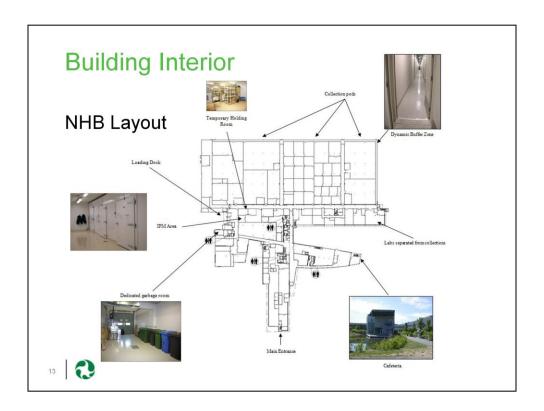
Here you can see a layout of the NHB highlighting some of the features I have been discussing.

The collections are all stored in the same area of the NHB, and separated into 3 separate pods. Each collection pod is surrounded by corridors and further divided into smaller collection rooms within each pod. No collection pod has exterior windows or walls, which significantly reduces the risk of pests.

Between the exterior walls of the NHB and the collection pod walls there is a dynamic buffer zone. This is essentially a narrow corridor that helps with environmental control and pest management. If pests do gain access to the building they have to cross the DBZ before they reach interior doors (used as emergency exits only) leading to the collection pods. This feature has shown to be very successful. We monitor both sides of the interior doors (DBZ and pods) and there is a significant difference in the number of pests discovered in the DBZ compared to the number found in collection pods, with the DBZ accounting for the largest number.

The cafeteria was designed to be a completely separate wing from all staff working areas and the collection pods. This provides a structural barrier via walls, as well as one of distance, between it and the collections. Although staff are permitted to eat at their desks, they are provided with sealed plastic containers to house food, are encouraged to store lunches in available fridges and to eat in the cafeteria.

All garbage that is collected in the building is stored in an isolated, sealed room off of the loading dock and away from collection areas until pick up.

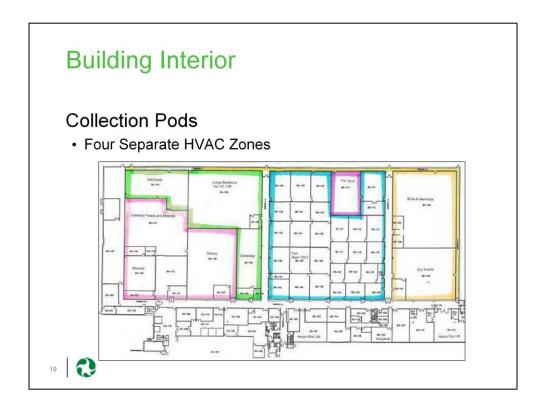
Within the collection pods, specific IPM related building design features assist in preventing, monitoring, and controlling pests.
