# On-boarding an IPM freezer

Eric Breitung – Department of Scientific Research – Research Scientist

11 March 2021

MuseumPests 2021

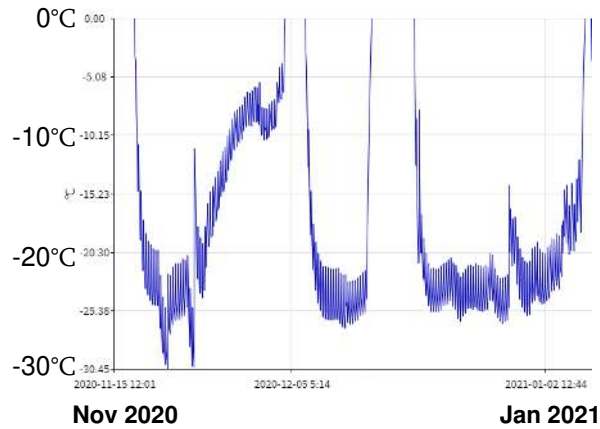
## Erratic and not reaching -35C

Open air sensor showing inconsistent low temps day to day and week to week

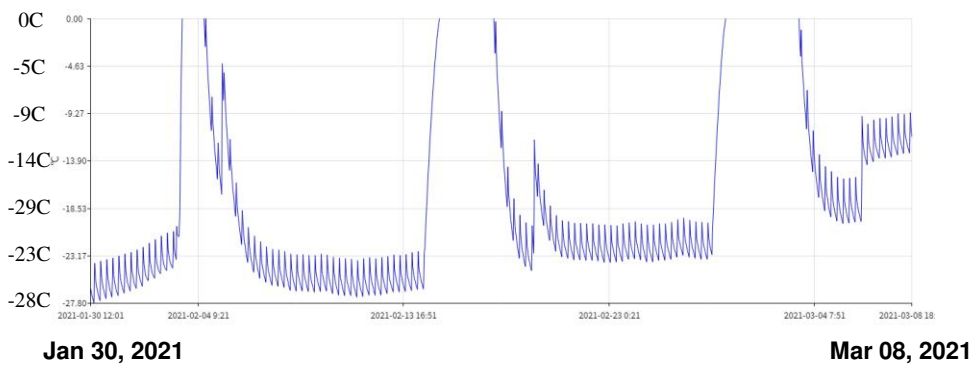
## Improved consistency, but $> -35C$

Open air sensor showing more consistent temps day to day,  
but slowly increasing week to week

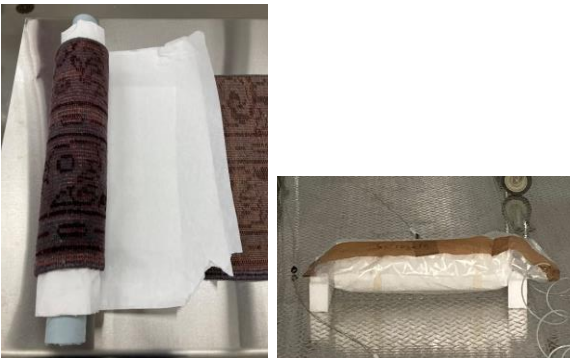
Textile/carpet:

Temperature sensor embedded into a rolled textile and block of wood.  
Textile wrapped with tissue & sealed in plastic bag. Wood is as shown.

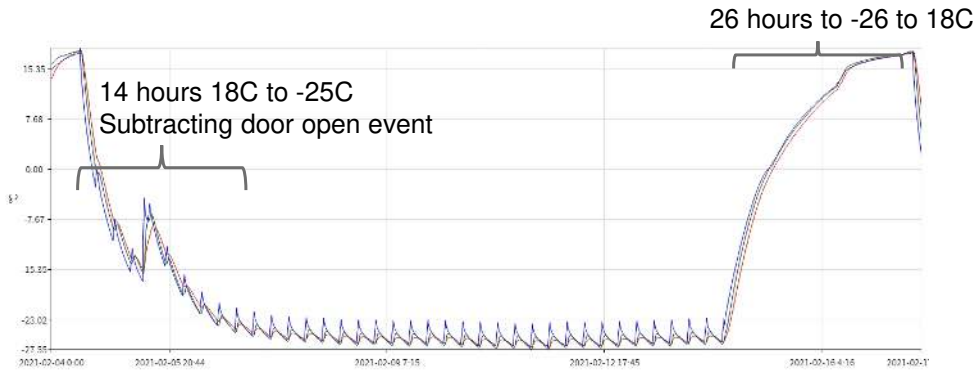
# Surrogates, times to low and high temps

Surrogates track the open freezer temperature  
Much longer than 6 hours to not even -35°C  
About 24 hours to warm to near room temperature
